Maintenance and Troubleshooting Guide V1.5

LEP-150-P, LEP-225-P Pump

QED Environmental Systems

ATZ PUMP MAINTENANCE & TROUBLESHOOTING GUIDE

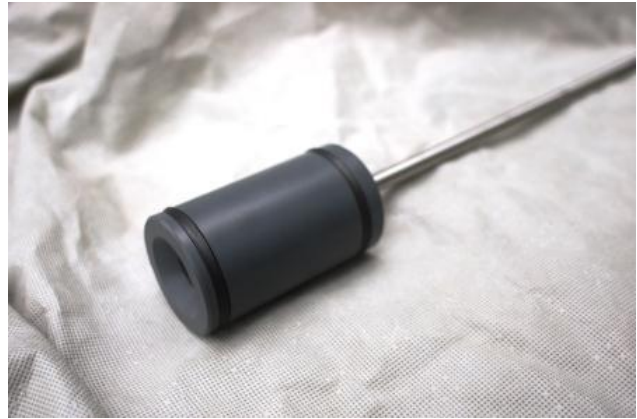
The piston assembly includes two U-cup straight seals. When pumping particulate filled leachate, the average life expectancy for these two piston seals is 3-4 months, whereas when pumping clean water one can expect at least 12-18 months before any changes need to be made.

Piston seal wear is indicated by an appreciable decrease in pumping output when other causes are ruled out. Even if the piston seals wear, the pump should continue to operate and continue to pump liquid.

In order to replace the U-cup seals on the piston, the lower pump assembly must be pulled from the well. Once disconnected from the drop assembly, the piston can then be pulled out the top end of the pump. Upon removal of the old seals, the new piston U-cup seals **MUST** be installed with the open end of "U" facing **UPWARD**. The piston assembly can be re-inserted into the cylinder body from the **TOP** end and plunged downward into position. Do not forget the 3/4" SS ball before re-screwing the cylinder seat into place.

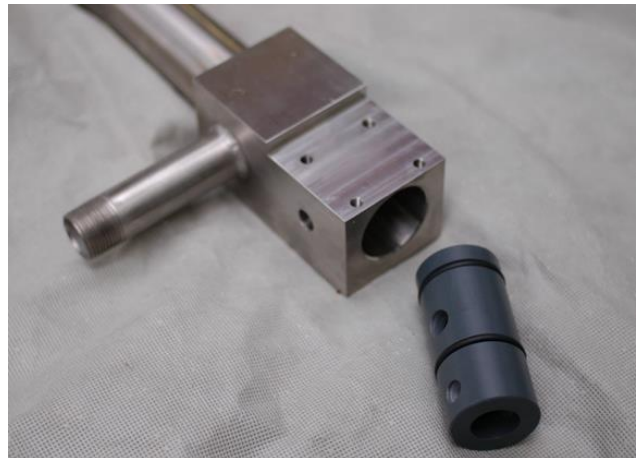
The pump head assembly includes our seal body as well as the seal body pin.

The seal body can be replaced as a complete assembly or replacement seal kits are also available. Many customers keep spare complete seal body assemblies on hand to be easily exchanged in the field, with additional seal kits to replace worn seals once the seal bodies are removed from the field.

If seals are to be installed on site, a blunted hook tool may aid the process. Take care not to puncture seals during installation.

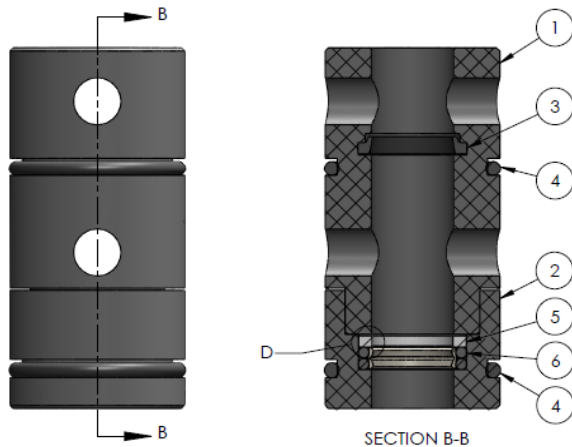
ITEM	DWG/PART NUMBER	DESCRIPTION	QTY
1	LP-SB-04	Upper Seal Body	1
2	LP-SB-05	Lower Seal Body	1
3	S5	Rod Wiper	1
4	S3	1-220 O-Ring	2
5	LP-SB-03	Wear Ring - Seal Body	1
6	S8	SKF Custom Seal	1

NOTE ORIENTATION OF WEAR RING SHOWN IN DETAIL D.

In order to replace the seals in the seal body, it must be removed from the pump head and unscrewed (in half). For proper function of the seal body, upon removal of the old seals the new seals **MUST** be installed following the diagram above.

The pump head and seal body incorporate a tell-tale seal wear indicator port which alerts technicians to the failure of the lower set of seals inside the seal body. This same port also accommodates the expansion of pumped liquid under freezing conditions, thereby preventing failure or destruction of the pump head assembly.

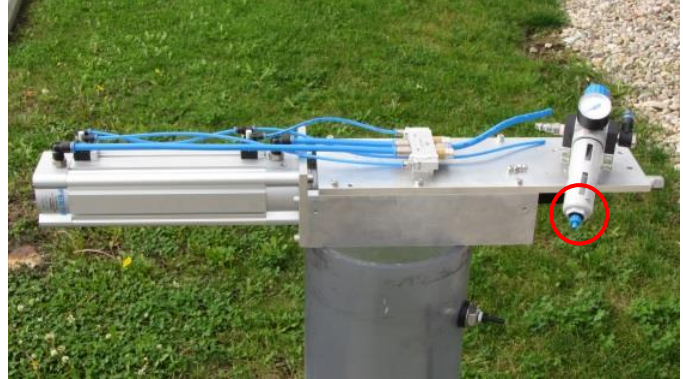
The operational lifespan of the pneumatic backplate assembly depends greatly on the dryness and cleanliness of the air supply. Drain water from the filter/regulator housing regularly by loosening then retightening the blue vent screw circled at right.

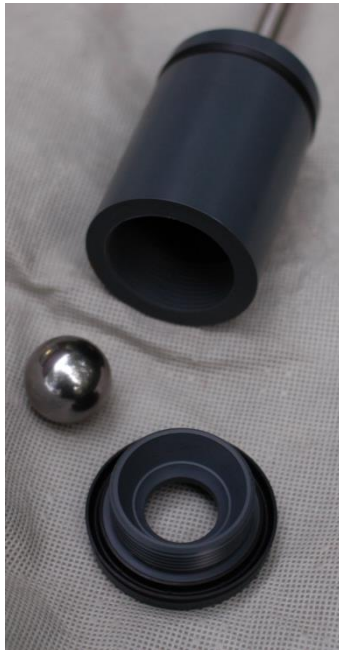
The lower pump assembly includes the PVC Piston and 2 x 316 series stainless steel balls, which may experience wear over time, especially with highly abrasive content in the leachate. The PVC piston and one ball are shown at left.

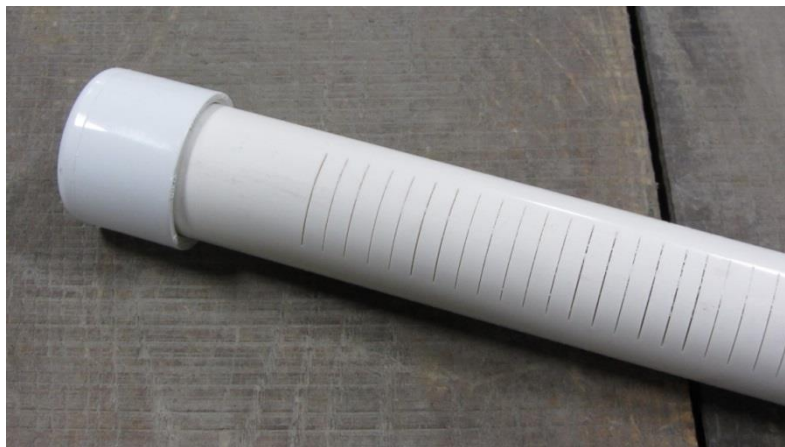
One of the best methods to reduce wear on the lower pump assembly and seals is through the use of our optional Intake Screen Filter, shown below. This simple slotted PVC pipe extends from the lower seat of the pump and provides an initial filtration of larger particles so as to reduce the abrasive elements entering the pump.

Portion of Intake Screen Filter, typically 24 inches in length
